INVENTORY

POTENTIAL and EXISTING UPSTREAM RESERVOIR SITES

SOUTH SHORE, CAPE COD, BUZZARDS BAY & ISLANDS STUDY AREAS

JUNE 1975

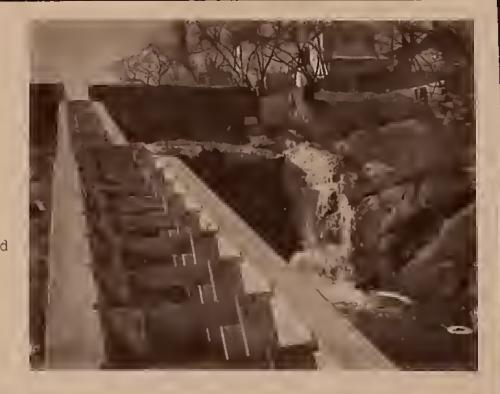
SS-2616 Whitmans Pond

The dam is an earthfill structure with a stone wall along the downstream face. The spillway is a concrete weir with four 5-foot wide bays. There is another spillway located near the left abutment, as well as a concrete fish ladder. It appears that the dam was recently reconstructed. The dam and spillways are in good condition.

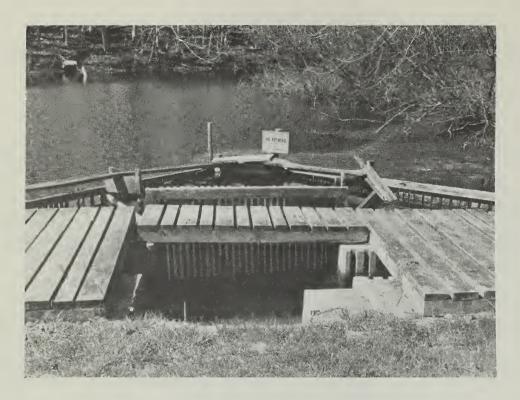
Existing Site CC-3201 (Upper Shawme Lake)

Old County Road forms the dam. The upstream face of the dam is a vertical granite-block wall. The spillway is a concrete pipe with flashboard control. Immediately upstream from the spillway inlet is a series of timber trash racks. There is also an auxiliary pipe spillway to deliver water to downstream trout pools. The dam and spillways are in good condition.

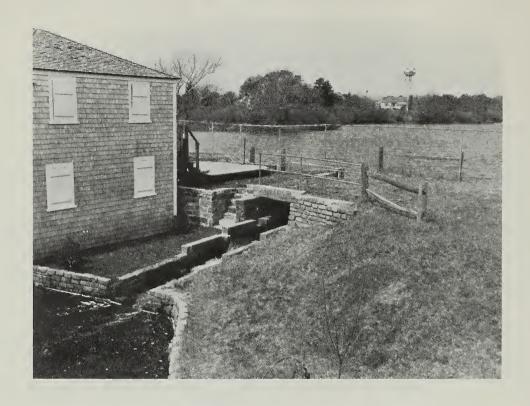
Existing Site CC-3802 (Mill Pond)

The dam is an earthfill structure. The spillway is a concrete weir with flashboard control which discharges through a box culvert to a concrete fish ladder. Concrete in the spillway is spalling in some areas. The dam is in good condition.

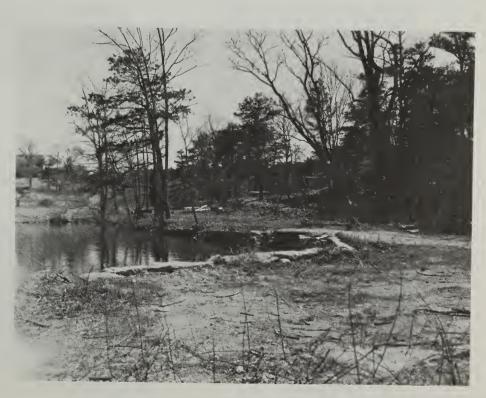
Existing Site CC-4001(Mill Pond)

The dam is an earthfill structure. The downstream face is a vertical stone wall. The principal spillway is a concrete weir about 2 feet long with flashboard control. There is also a small spillway which also acts as a fish ladder. There is about one foot of free-board between the pond level and top of dam. It appears that the dam had recently washed out. Repairs have been made to the downstream end of the principal spillway and trees and brush have been removed from the dam.

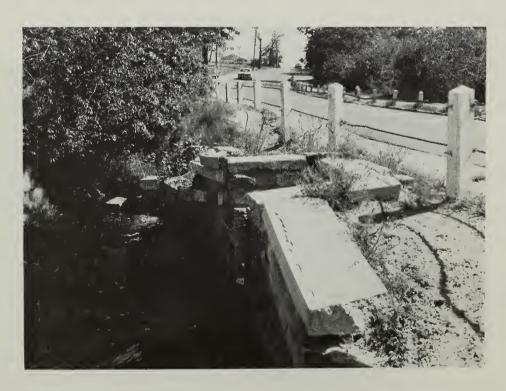
Existing Site CC-4004 (Mill Pond)

Shore Road forms the dam. The spillway is a concrete box culvert. The downstream end of the spillway has provision for flashboards. There is a concrete fish ladder to the right of the principal spillway. Flow from the principal spillway reaches a tidal pool by means of a concrete chute. Seepage was noted at the downstream toe of the roadfill. Concrete in the spillways is in good condition.

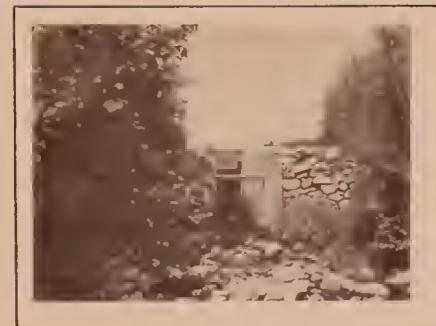
BB - 6401 Tinkham Pond

Tinkham Lane forms the dam. There are two spillways. The principal spillway is a double-bay concrete flume with flashboards. The other spillway is a rectangular three-bay concrete drop structure which outlets to a stone box culvert. Trees and brush are growing on the dam. Concrete in the spillways has spalled.
